Anesthesiology
 1997; 86:993-4
 © 1997 American Society of Anesthesiologists, Inc.
 Lippincott-Raven Publishers

An Unexpected Cause of Magnetic Resonance Image Distortion: The Endotracheal Tube Pilot Balloon

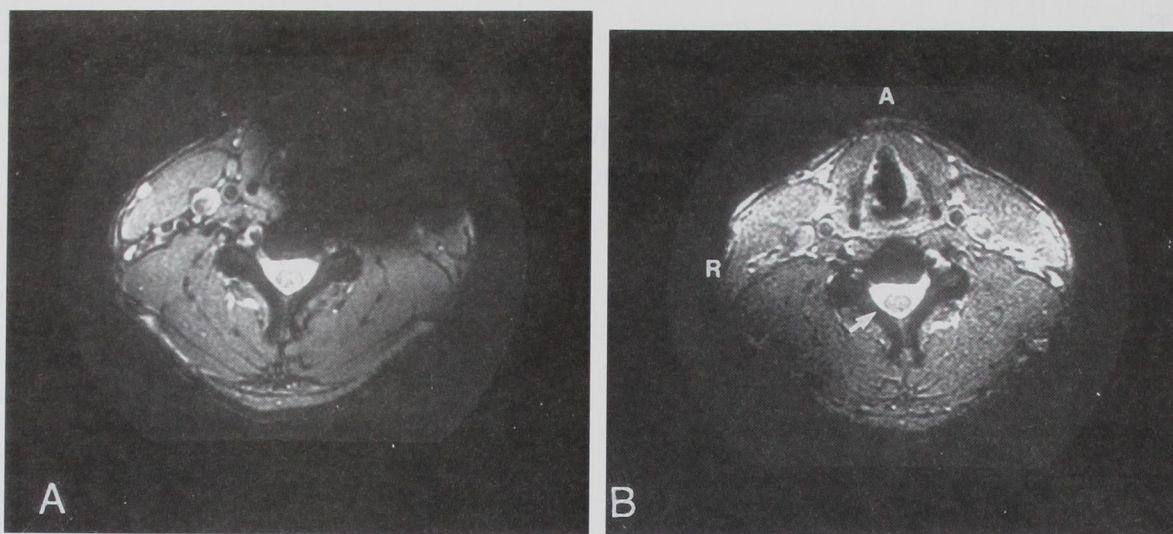
A 17-yr-old trauma patient with a known L₄ burst fracture required general anesthesia for a detailed MR examination of the spine and paraspinal region. After successful induction of general anesthesia, the patient's trachea was intubated with a 7.0 cuffed endotracheal tube (Lo-Pro; Mallinkrodt Medical, St. Louis, MO). The initial T₂-weighted, gradient recalled MR examination revealed gross image degradation in the sagittal and transverse sections of the cervical spine region. The image artifact was consistent with ferromagnetic interference. A search for a source of ferromagnetic interference was initially unsuccessful. A radiology technician reported that similar interference had been observed in the past and was related to the position of the pilot balloon. Repositioning the pilot balloon 5 cm away from the surface of the neck area eliminated the distortion in a repeated MR scan. Subsequent inspection of the pilot balloon revealed a ferromagnetic spring that closes the pilot balloon valve.

This case illustrates how even a very small ferromagnetic object can severely distort a magnetic resonance image in an adult patient. Brenn and Saldutti³ reported a similar episode of ferromagnetic interference during an MRI scan in a 6-month-old infant. The larger body size of the adult and the greater distance from the skin and pilot balloon to the internal structures to be examined does not appear to offer any significant protection of MRI quality. Pilot balloon springs of oral RAE tubes and laryngeal mask airways have also been implicated in MRI degradation.^{4,5} The spring within the pilot balloon valve apparatus (Bespak PVC Medical Check Valve, Tenax Corporation, Apex, NC) is made of stainless steel and causes the image distortion. Image degradation only occurs when the pilot balloon valve containing this spring lies directly on the area of the head or neck to be scanned (fig. 1). According to the manufacturer (Tenax Corporation), this spring is present in all biomedical pilot balloon valves. Although plastic versions have been used in the past, the spring is best made of stainless steel because of its small size and the need for highly reliable operation. The risk for direct patient injury *via* induced heat production or dislocation of the valve spring is insignificant. The type of image distortion described by this report is easily avoided by placing the pilot balloon as far from the area to be examined as possible. We have found it convenient to secure the pilot balloon near the y-connector of the anesthesia circuit, thereby separat-

Fig. 1. (A) Axial magnetic resonance image (MRI) of the cervical region showing the large artifact attributable to ferromagnetic interference. (B) Result of a repeated MRI using the same image plane and MR technique as in A. The pilot balloon has been attached to the y-connector of the ventilator tubing, eliminating the ferromagnetic image distortion. A = anterior; R = patient's right; arrow indicates the spinal canal.

ing the pilot balloon from the skin surface by at least 3 cm and preventing image distortion.
