## Scalp burns from halo pins following magnetic resonance imaging

### Case illustration

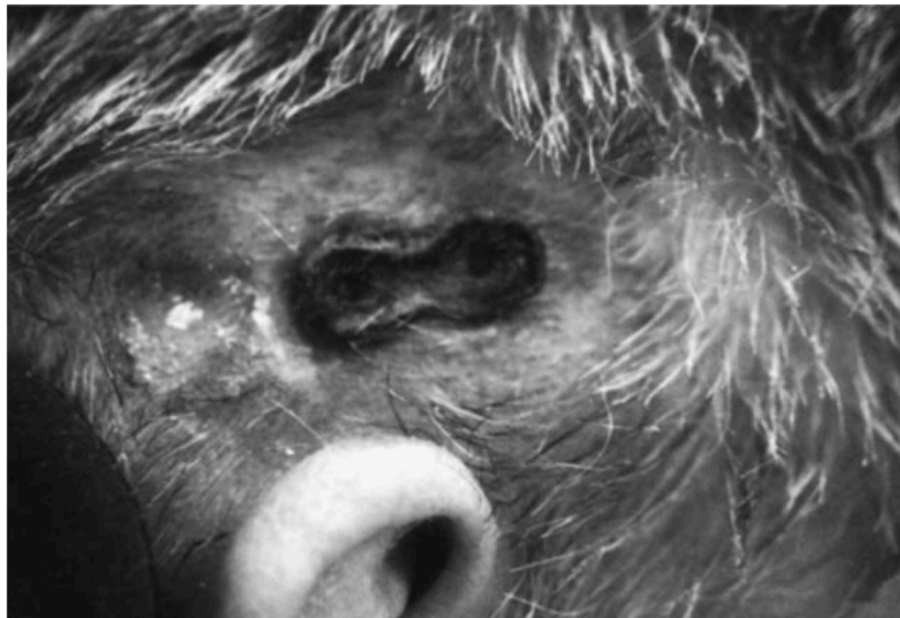
FIG. 1. Photograph of MR imaging-associated scalp burns at the two right posterior pins in the six-pin halo construct. Note the evidence of an old pin site (left side).

We report on the first case of a scalp burn from halo pins as a complication of magnetic resonance (MR) imaging. (Note that other patients at our institution have complained of a focal heating sensation at halo-pin sites during MR imaging.) A 58-year-old man with a cervical epidural abscess underwent an anterior cervical corpectomy and allograft fusion with cervical plating. Postoperatively, the patient was placed in a titanium six-pin halo-vest fixation device and underwent cervical MR imaging in a 1.5-tesla magnet. Afterward, burn marks were evident on the scalp at the right two posterior pins (Fig. 1). The stoic patient had clearly perceived significant burning pain during MR imaging, but did not notify the technicians.

Electrical current, radiofrequency energy, and microvibrational energy are plausible generators of heat during MR imaging.<sup>2-4</sup> As a halo pin transmits this energy to the skin, it is perceived as a heat sensation. Enough energy was produced to burn the patient's scalp in our case. The cause of MR imaging-related burns from halo pins and other medical devices is unknown but has been attributed to monitoring equipment and even skin tattoos.<sup>1,5</sup> Physicists and engineers must define the mechanisms that produce thermal injury so that preventive measures can be instituted. Theoretically, insulating any conductive pathways within the halo device at its interface with the patient's scalp should alleviate this problem. At our institution, a prototype of a nonconductive pin has caused no instance of burning or discomfort at the pin site during MR imaging.
