Review Article

Unwanted effects due to interactions between dental materials and magnetic resonance imaging: a review of the literature

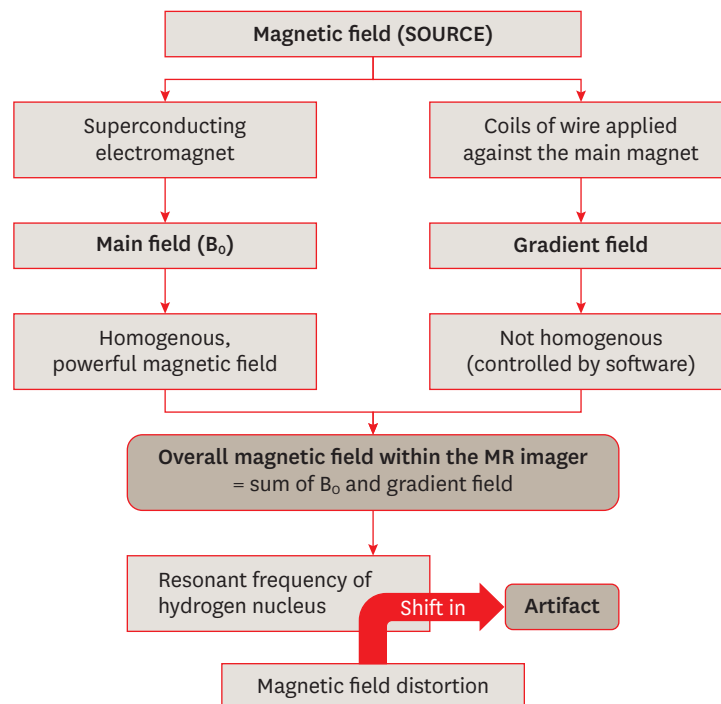
Figure 1. Mechanism of artifact formation. MR, magnetic resonance.

The mechanisms of artifact formation and other interactions can be understood by reviewing the principles of MRI (**Figure 1**). MR is based on the dependence of the resonant frequency of a hydrogen (H) nucleus on the strength of the magnetic field to which the nucleus is exposed. Any distortion of the magnetic field, either by intrinsic or extrinsic effects, will therefore result in spatial distortion of the image; that is, the distortion of the magnetic field at a certain point shifts the resonant frequency of the H nuclei at that point [6]. **Figure 1** summarizes the mechanism of MRI and artifact formation. In the case of dental materials, there are 2 potential sources of artifacts in MRI.

1) Distortion of the static magnetic field (B_0) due to differences in the magnetic susceptibility of materials and body tissues

A susceptibility artifact (SA) is defined as signal incoherence generated by the intermingling of substances with discrepant capacities to be magnetized (measured by χ , susceptibility). Because most body tissues are diamagnetic (not very magnetizable), proximity to substances with highly magnetic properties (*i.e.*, ferromagnetic materials) induces SAs.

2) Eddy currents

These are induced by alternating gradients and radiofrequency magnetic fields. The induced eddy currents distort the applied magnetic field, leading to image distortion [8]. Eddy current artifacts due to metallic objects within the MRI field are referred to as non-SAs [35].

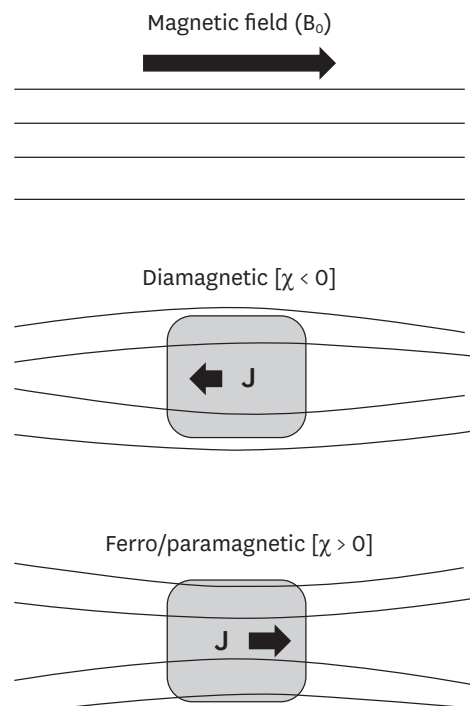
Figure 2. Classification of materials according to their interactions with magnetic fields. χ , magnetic susceptibility (synonym = magnetizability); J, Polarization or Internal magnetization.

With regard to magnetic effects, 3 classes of materials exist (**Table 2**; **Figure 2**). Nearly all biological tissues are weakly diamagnetic. Other than trace amounts of magnetite, there
